July 25, 2024

G-5440

Subject: **GEOTECHNICAL REPORT
PROPOSED LOT SUBDIVISION
375 MT OLYMPUS DR NW
ISSAQUAH, WASHINGTON**

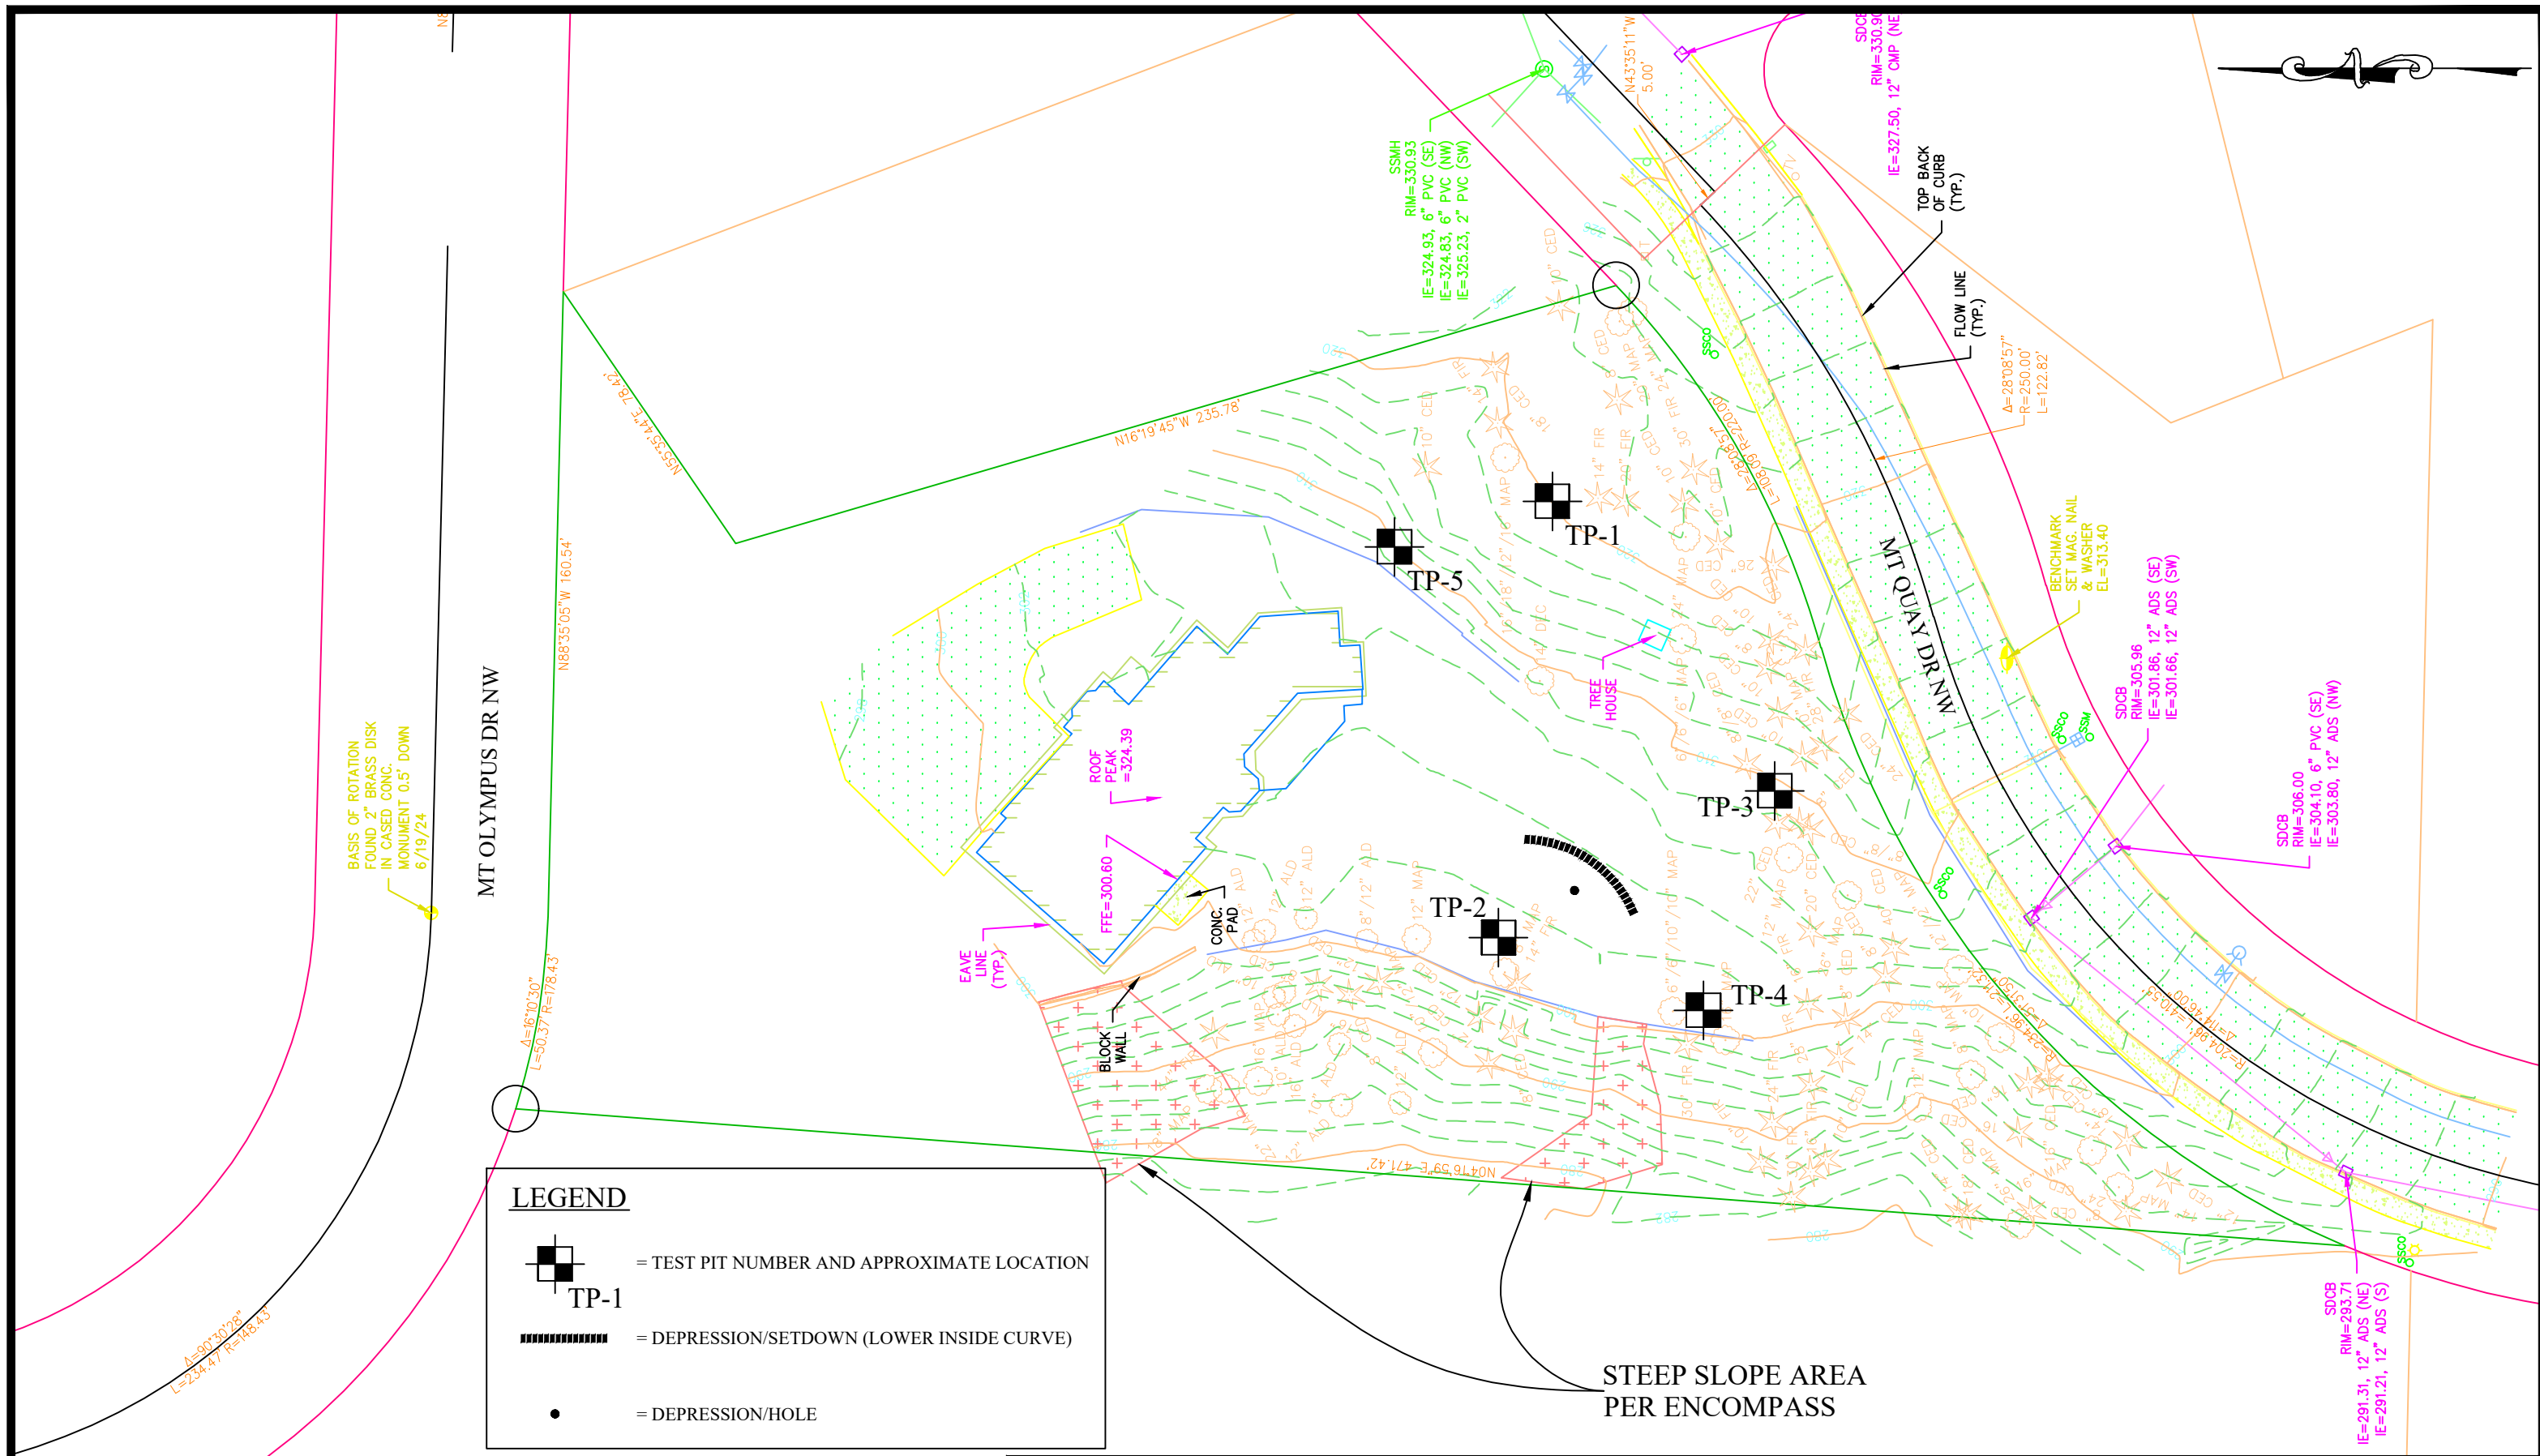
PROJECT #:	G-5440
DATE:	7-24-2024
DRAWN:	AG
CHECKED:	WC
SCALE:	1" = 40'
PLATE:	2

The project surveyor has provided a survey which is attached as **Plate 2 – Topographic Survey**. The survey delineates two Steep Slope Hazard areas located at the west side of the site.

Per our measurements of slope inclinations based upon the survey contours, the west slope area has slope inclinations ranging from 35 to 46 percent with perhaps an average or median somewhere around 40 percent. We note that GIS mapping indicates that the west slope area extends off-site to the developed area at the adjacent west parcel having an approximate slope height of 55-feet and similar moderate to steep inclinations such as shown via the contours on the topographic survey. We suggest that perhaps the Steep Slope Hazard delineation line should be located at the 300-foot contour “top of slope”, however, this is speculative as we do not have

data showing the full extent of the 280-foot elevation contour. Presumably the surveyor has delineated the regulated steep slope area in accordance with the code definition.

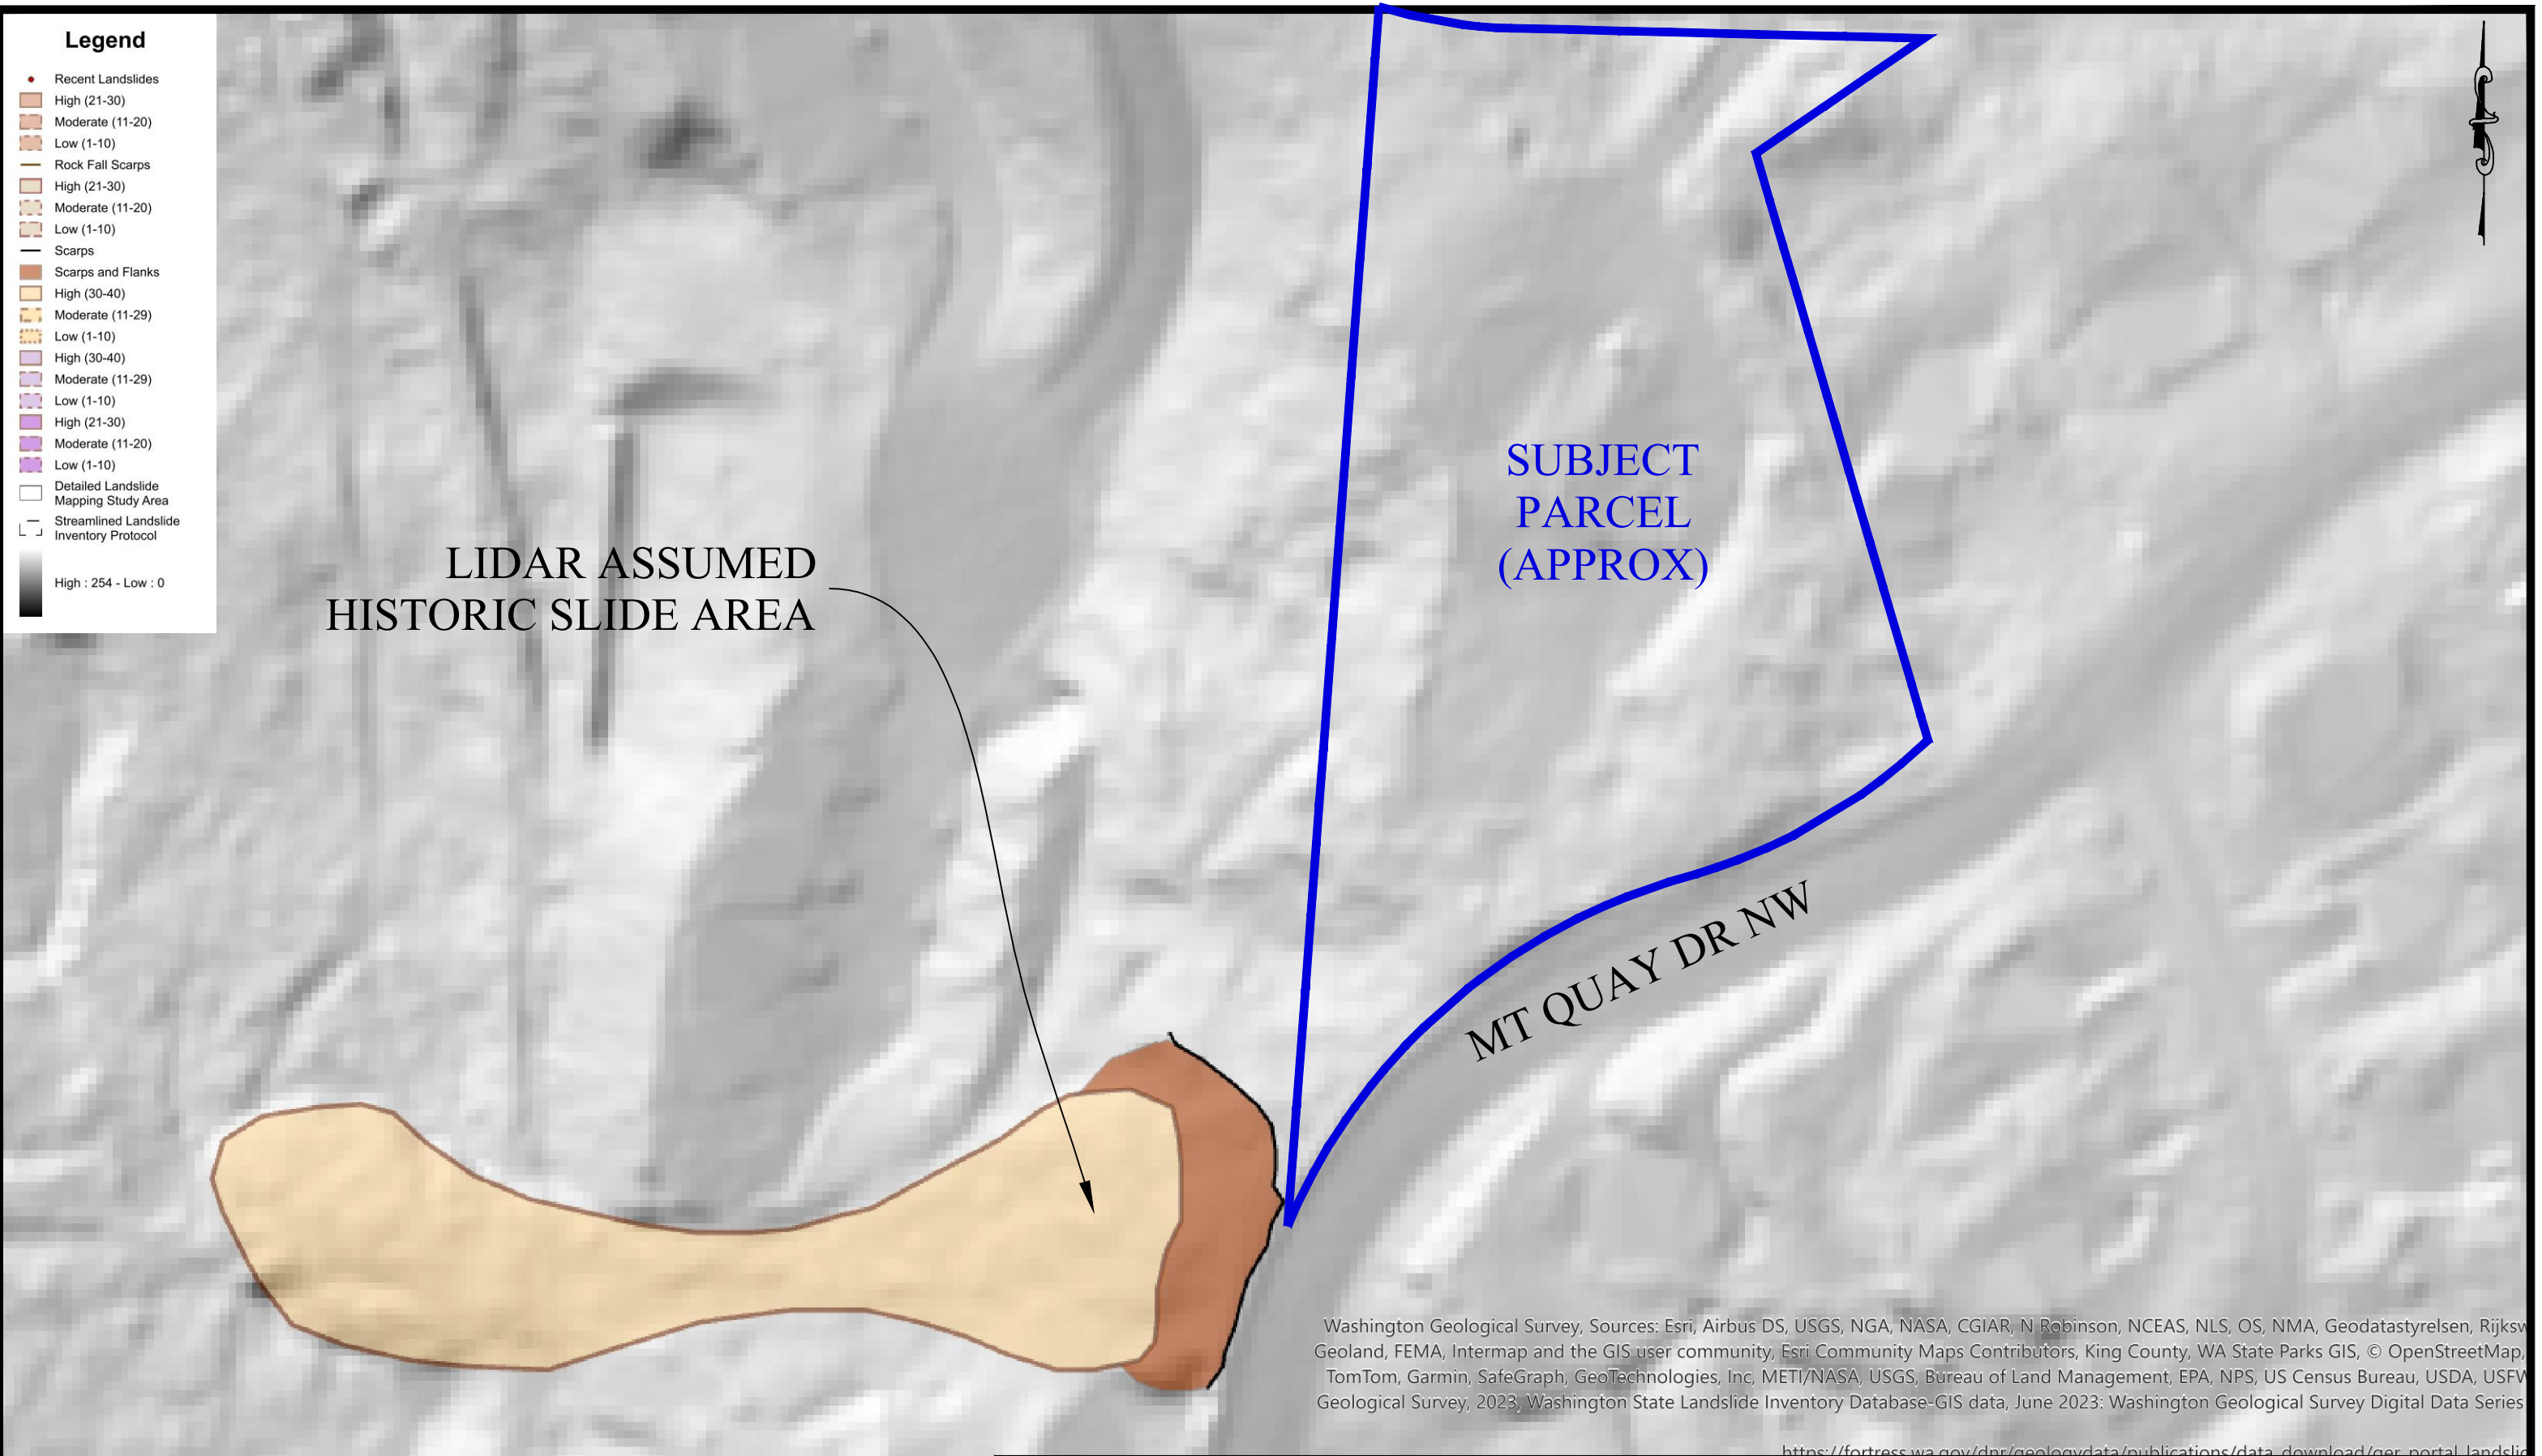
WA DNR Geologic Portal Lidar mapping and the associated paper², a copy of the map which is attached as **Plate 4 – Lidar Mapping**, suggests that there may have been a landslide located just southwest of the subject site. The potential/assumed landslide features are assigned the identification number of #6160. We note that the metadata associated with this particular feature indicate that the slide occurred in 1997, but we have not been able to identify how that age determination was made. The Lidar datasets used for the study are from 2003 to 2016 and the metadata indicates that field verification did not occur. Without field documentation of the landslide at time of occurrence it is our opinion that the Lidar feature, although it may be indicative of slope movement, could have occurred at any time between the present day and glacial retreat 14,000 years before present. It appears that the 1997 landslide occurrence date may potentially correlate with the southerly extension of Mt. Quarry Dr NW, near the southeast corner of the subject property.

Perhaps the rock-covered slope area is the area where the slope movement occurred and was subsequently repaired.

The landslide documentation which we reviewed for the Thompson Townhomes development suggests that sub-standard fill compaction occurred which is a primary causal factor related to the apparent soil settlement and slope movement. Once movement occurred than damage occurred to the drainage structures, which likely further worsened the movement and complicated the repair. In summary, it appears that the documented historical landslides in the subject site vicinity were generally human-caused and potentially avoidable through proper planning and construction implementation; they do not appear to be particularly related to the in-situ or natural subsurface conditions
