**Report
Geotechnical Engineering Services
Preliminary Coal Mine Hazard Assessment
King County Parcel Nos. 332406-9029,
-9036, -9039,-9045 and -9066
Issaquah, Washington**

**July 7, 2015
ICE File No. 1131-001**

**Prepared For:
Boardwalk Real Estate LLC**

**Prepared By:
Icicle Creek Engineers, Inc.**

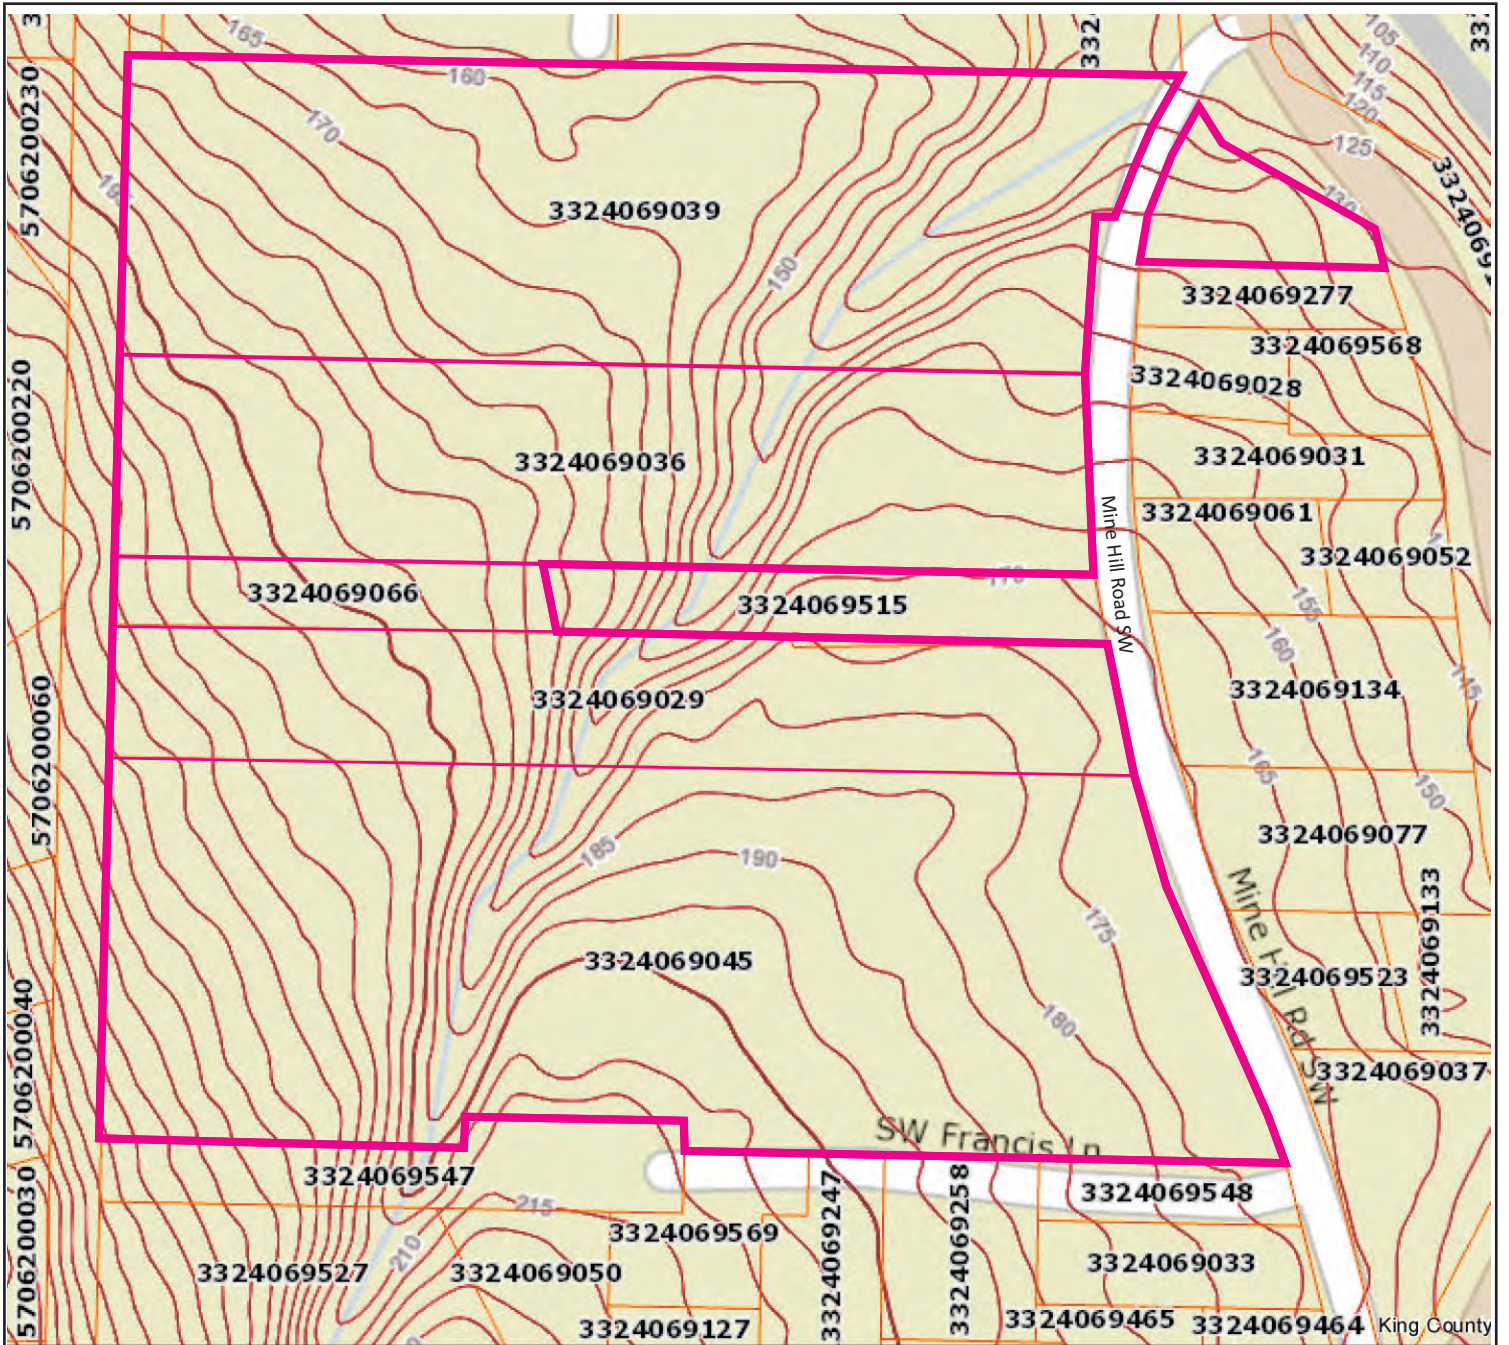
ICE FILE NO.
1131-001
Figure
2

SITE PLAN
